5830  
Ser N00/151  
7 May 19

From: Commander, U.S. Fleet Forces Command  
To: File

Subj: COMMAND INVESTIGATION INTO THE DEATH OF ENS SARAH JOY  
MITCHELL, USN, AT SEA, ON 8 JULY 2018

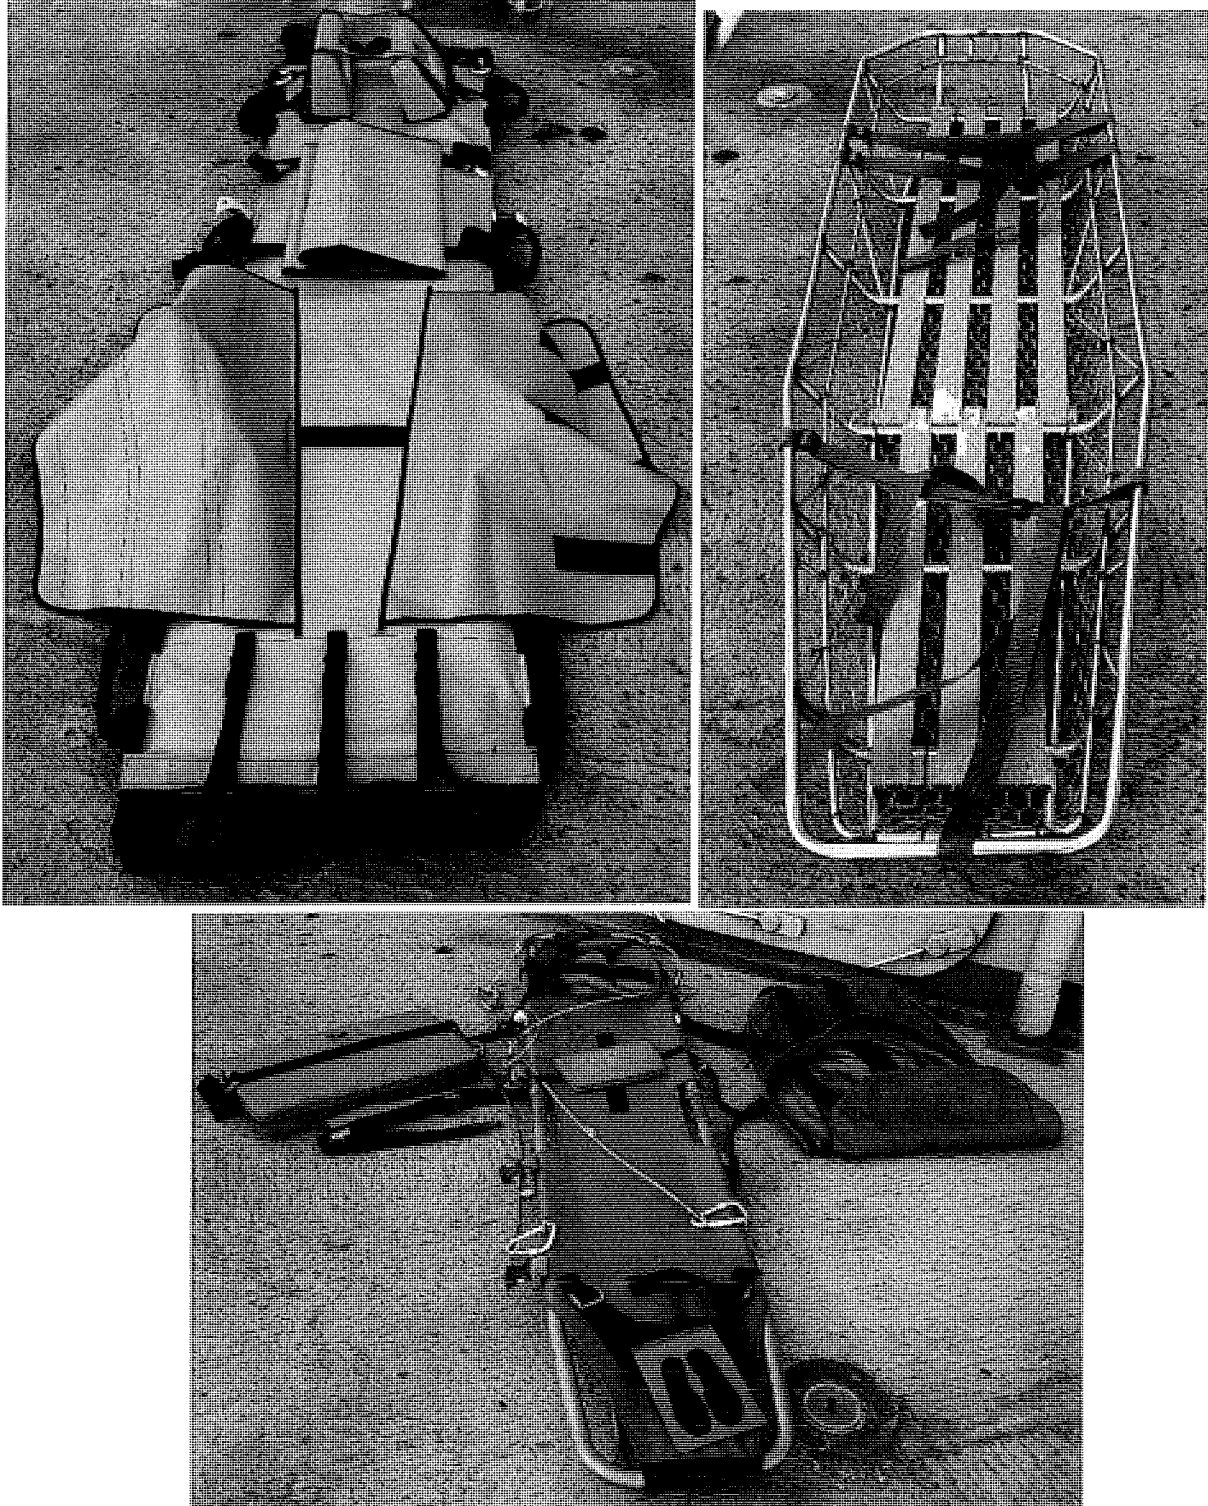
169. (b)(6) requested a litter and initially received a Stokes litter, see figure 5. [Encls (7), (24)]

*Figure 5, Clockwise from upper left corner: Investigator's photograph of the JASON DUNHAM Reeves sleeve; Investigator's photograph of the JASON DUNHAM Stokes litter; Investigator's photograph of the JASON DUNHAM SAR litter*

c. The third option never considered by the boat deck but requested by the RIB crew, was to recover by the SAR litter (see figure 5). JASON DUNHAM was certified with SAR litter, but had only been trained to do so by using the J-Bar Davit. Per reference (k), this is the only option of the three that provides a horizontal versus vertical extraction. This is also the type of litter that the RIB boat crew requested. No one on JASON DUNHAM recalls hearing the request specifically for a SAR litter. Training on the SAR litter would increase familiarity and make personnel more likely to consider it as an option should they face a similar situation again. [FF (169-176, 180, 184, 188)]
